A Conservation Assessment of the Classics Library, UT Austin
Sarah Norris
May 8, 2008
Protection and Care of Archival Materials, Spring 2008
Karen Pavelka

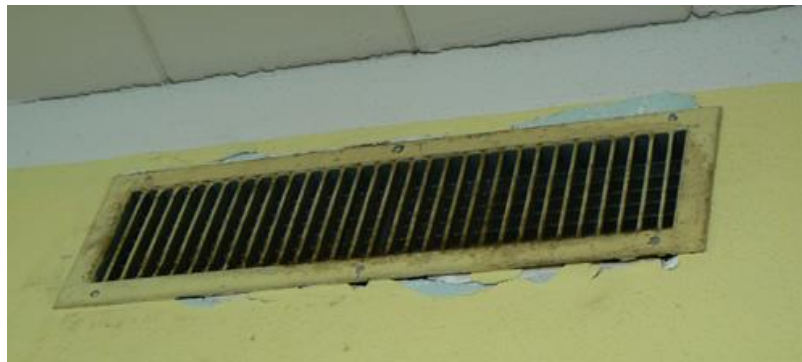
In past years, the library air vents periodically produced clouds of dark, soot-like dirt that landed on the items directly below. Staff do not know the reason for this dirt, and had to clean the mess themselves, although the problem has not occurred recently. Chipping paint and wall cracks are evident around vents throughout the collection, perhaps indicating the presence of HVAC-caused moisture in these areas. Chips of older paint could also contain lead.

Vent with chipped paint.

- Install environmental monitoring equipment in rooms with extreme temperatures to support future conversations with maintenance staff and HVAC engineers.
- Monitor the vents for condensation. If this problem is persistent, report it to UT HVAC personnel.
- Ask UT repair staff to repaint chipped vent areas to seal possible lead paint.
- Ask University grounds staff to seal open crawl spaces beneath the building.
- Keep spill pillows on site in case of future flooding from the soda machine or from outdoors. (Available from library and archival suppliers.)
- Monitor holes and perforations in tiles for insect activity. Consider caulking these holes or replacing the tiles should activity be observed.
- Consider caulking the broken window without UT assistance to moderate environmental fluctuations.

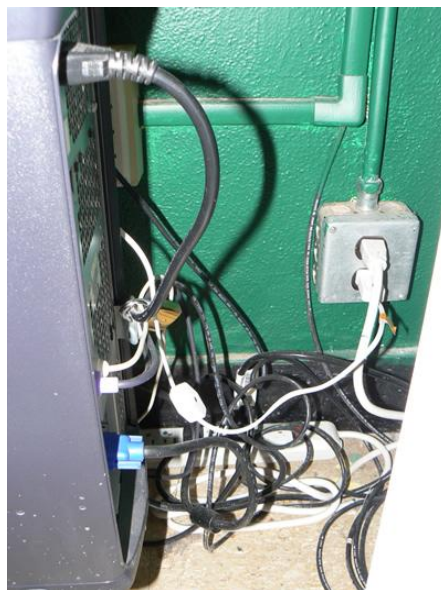
When Waggener Hall was built in 1931, electrical requirements were relatively light. Today, in the Classics Library, the few electrical outlets are crowded with power strips supporting computers, printers, telephones, lighting, a microwave, a coffee maker, a small refrigerator, and other small appliances. Staff has expressed warranted concerns about a resulting fire hazard.

Overloaded electrical outlet

- Place a fire extinguisher in every room.
- Ensure that all users know the location of fire extinguishers. This information could be included in a new users' orientation packet..
- Turn off electrical appliances when not in use, and unplug them when staff goes home for the night. This could be easily accomplished by plugging all optional appliances into identified power strips, which could be disconnected at day's end.

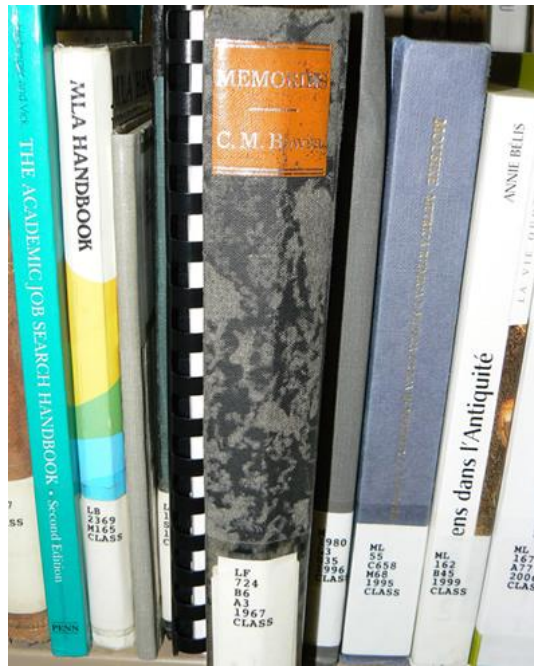
Evidence of flies, spiders, and silverfish appears in windowsills and underneath cabinets. Insect grazing, primarily by roaches, appears on the spines of many volumes in the collection. A live silverfish was identified in a plywood spaceholder on a shelf.

Spine showing evidence of roach grazing.

- Establish a regular pest control program with the University. Enlist the help of Jennifer Lee, UT's Head of Preservation, to emphasize the importance of this issue with university administrators.

- Replace old insect traps with new ones, and establish a spreadsheet and inspection schedule to quantify, record, and track insect activity to support future conversations with UT pest control personnel.

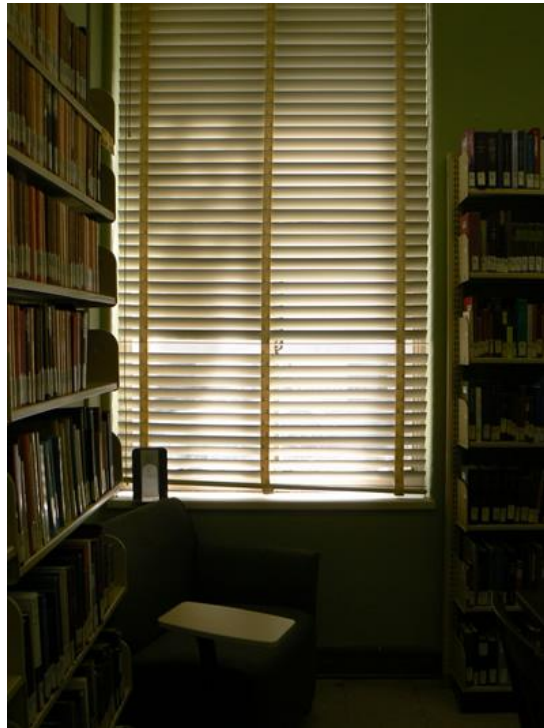
The Classics Library is filled with windows and attractive natural light. Due to each room's small size, bookshelves must be placed in front of these windows. Wide-slat, wooden, painted blinds cover all the windows, and the blinds are regularly left closed to lessen light damage. Nevertheless, items near windows receive an elevated dose of natural light, in addition to the fluorescent light used in the interior space.

Typical window and blinds.

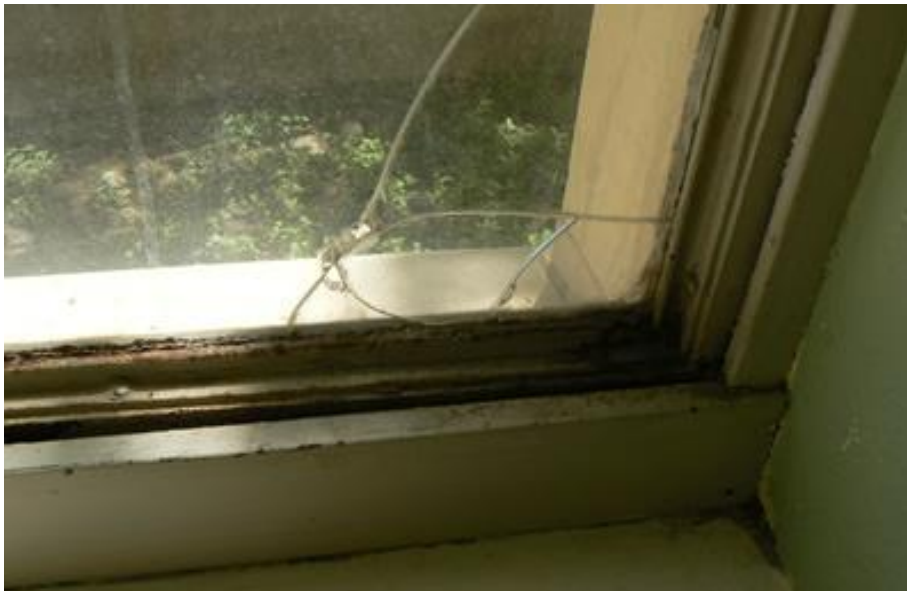
While the measured temperature fluctuated only 3.8 degrees from room to room, RH fluctuated fully 12.6%. RH spiked at 58.7% in Room 2a, near the cracked window. This not only poses a threat to hygroscopic materials, but provides a favorable environment for insects like silverfish. RH in the closed stacks was overall lower, averaging only 46.4%. This difference may simply reflect a lower number of visitors. The door to the hallway is opened less in the closed stacks than in the open stacks, so that environment is under greater HVAC control.

Cracked window.

- Caulk the crack in the window to help control RH.
